ERICSSON REVIEW

Vol. XXXIII

No. 3

Application of 8-Channel Open-Wire Carrier Telephone Systems in Brazil

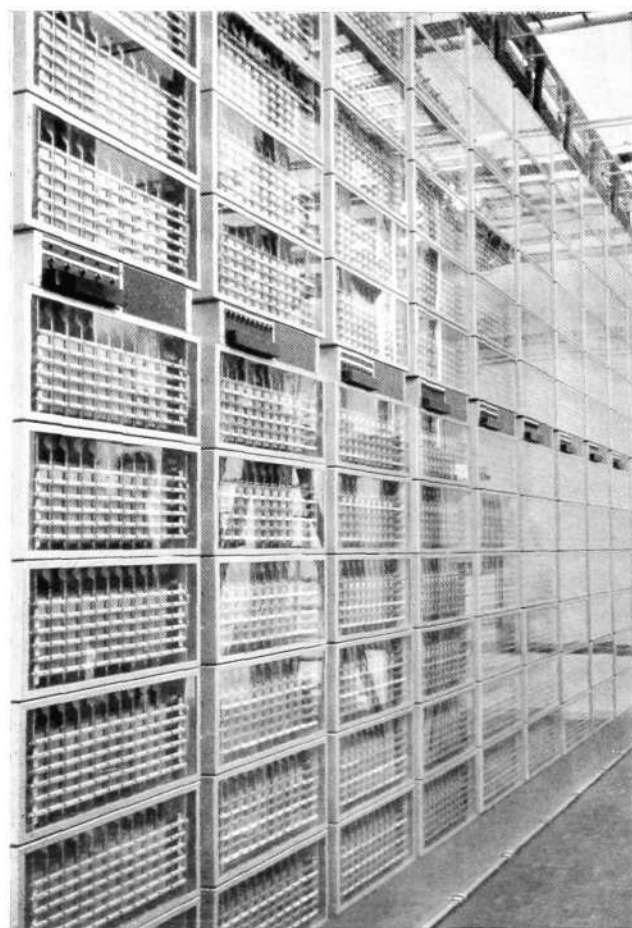
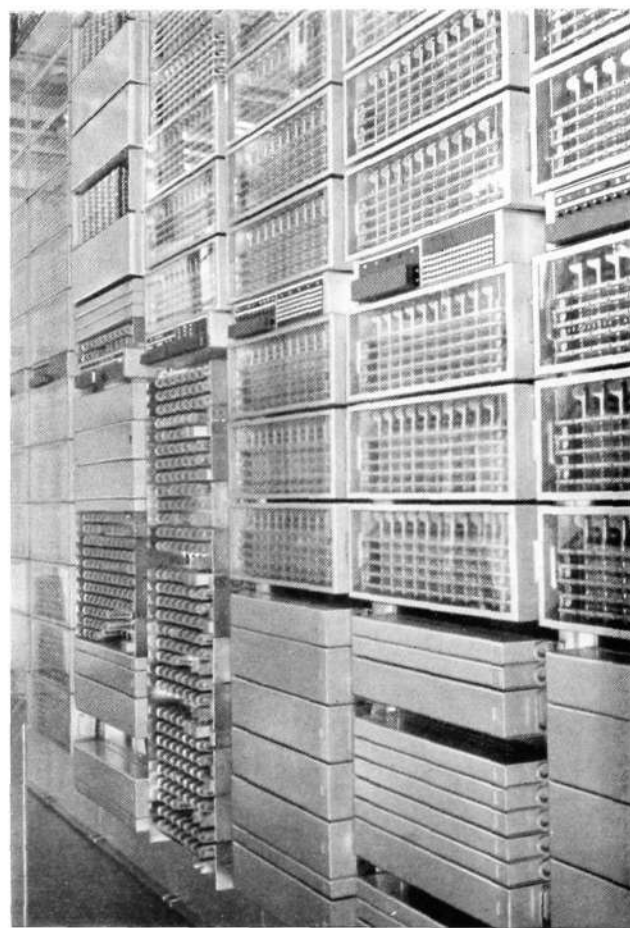
X 6969
X 6970

(Left) IIGV racks, (right) marker and register racks

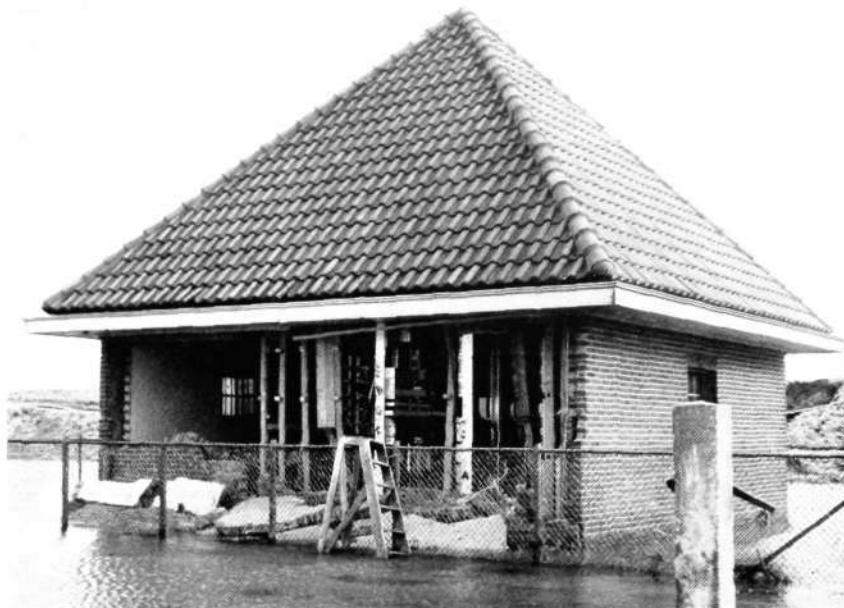
X 6971

Fig. 4
Stellendam terminal exchange
during floods in February 1953

The exchanges Herkingen and Ouddorp were heavily damaged, and Stellendam was a total loss (fig. 4). In the Middelharnis exchange the ground floor was flooded, but the automatic equipment being situated on the first floor continued to operate. The exchange at last broke down owing to failure of the power supply. Two hours later a rescue party arrived with an emergency power set and the exchange soon was in working condition again. The exchanges Dirksland and Stad a/h Haringvliet escaped damage.

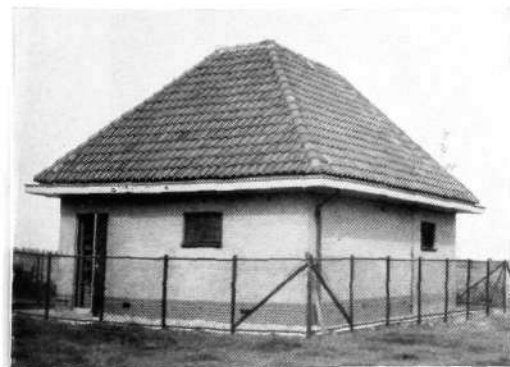
X 2146

Fig. 5
Dirksland terminal exchange

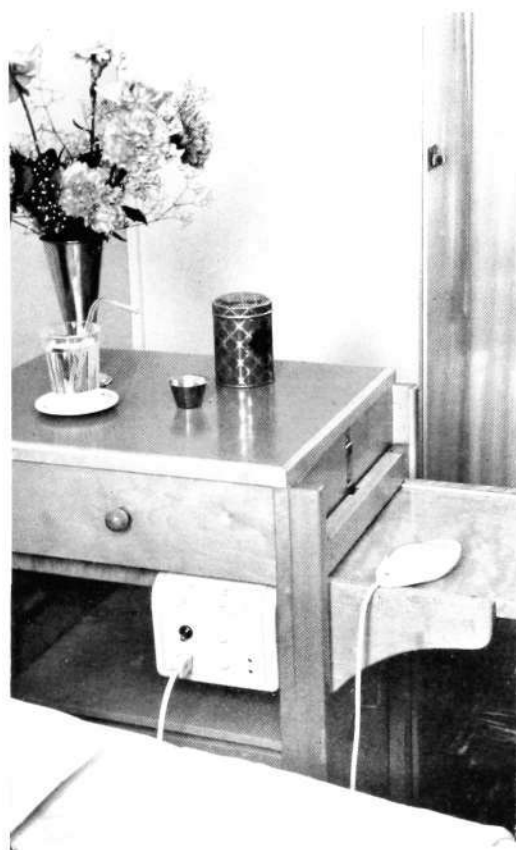
X 2152

Fig. 2

The patients' *bedside switch panels* may be of different designs according to the type and method of operation of the telesignalling system. The most common form is a panel as shown in fig. 2, containing all controls the patient has to operate personally—nurse call button, bedlamp switch, socket for pillowspeaker with volume control, and a socket for a pendant push which the patient can hold in his hand and operate very easily if severely ill and unable to reach the panel.

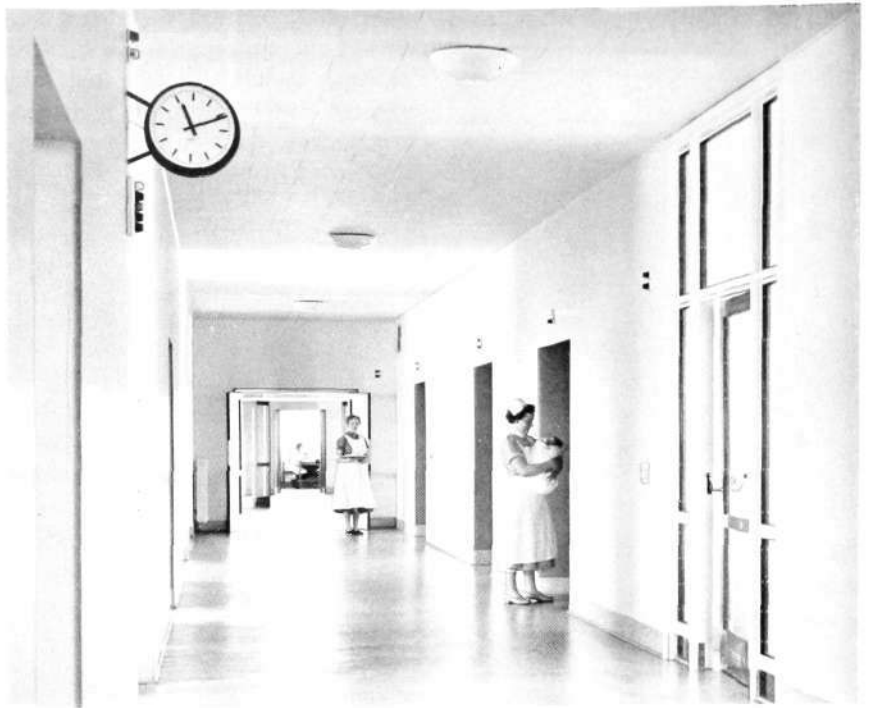
One of the hospital corridors with a slave clock on the left and, under it, a paging indicator

The overdoor room indicators are seen outside the doors on the right

The overdoor room indicator (fig. 5) outside the door of each room has a green and a red lamp mounted vertically on a recessed panel. The red lamp indicates that a patient in the room has called the nurse, and the green lamp that the nurse is in that room.

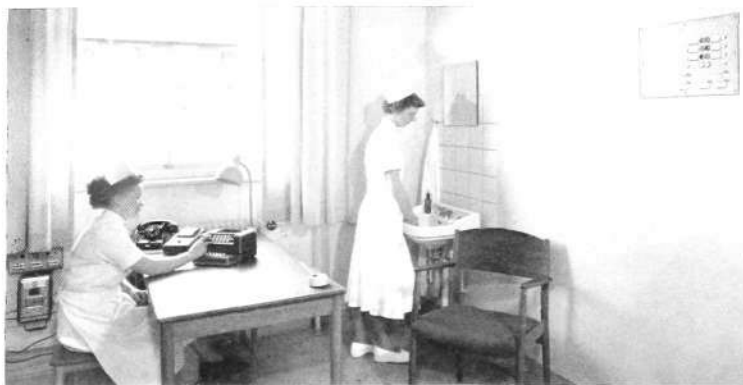
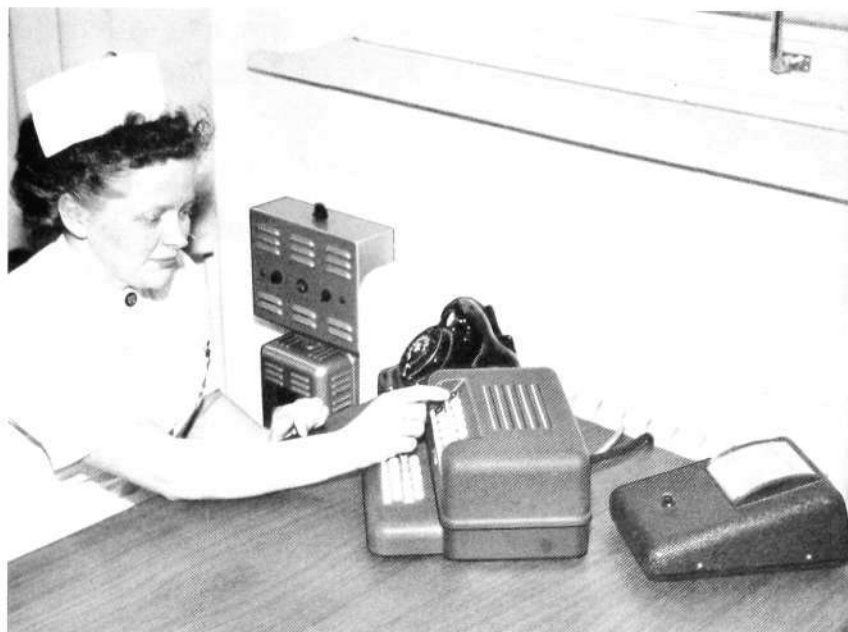
X 6983

Fig. 7

Master set of intercom system

for conversations with the various wards.
(Right) Master set of infants' supervision
system.

The master set (fig. 7), which is the intercom "switchboard", is placed on a table in the nurses' office. The amplifier is fitted to the wall beside the table. Calls to patients are switched from the master set, which contains a speak-and-listen key and a call lamp for each ward in the department. The call lamps are placed on a key base below the master set and indicate from which room a call has originated.

The master set (fig. 7) contains a microphone-loudspeaker, switch and speak button; the sub-set is a microphone-loudspeaker.

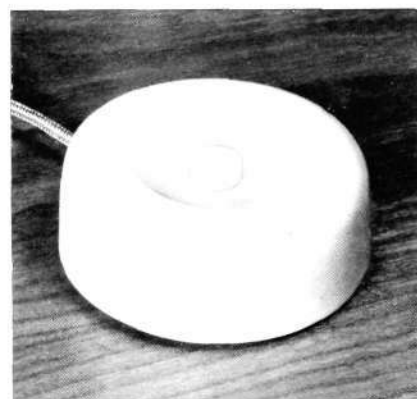
Fig. 8 b X 2172
Pushbutton switch KEM 2011

The duty nurse has a push button (fig. 8 b) which produces an audible signal in the waiting room and lights an illuminated panel with the text "Next patient" (fig. 9). The signal continues only as long as the button is depressed, but the text on the panel remains illuminated until the next patient opens the door from the waiting room to the nurse's office. This is effected by a door contact which causes the resetting relay to extinguish the illuminated text.

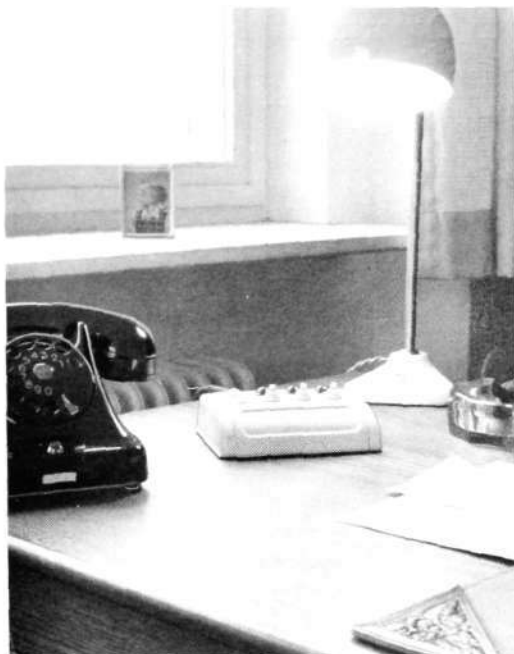
Fig. 10 X 2157
Senior physician's desk with control set connected to wall panel outside the door. "Engaged", "Wait" or "Come In" may be signalled, as desired.

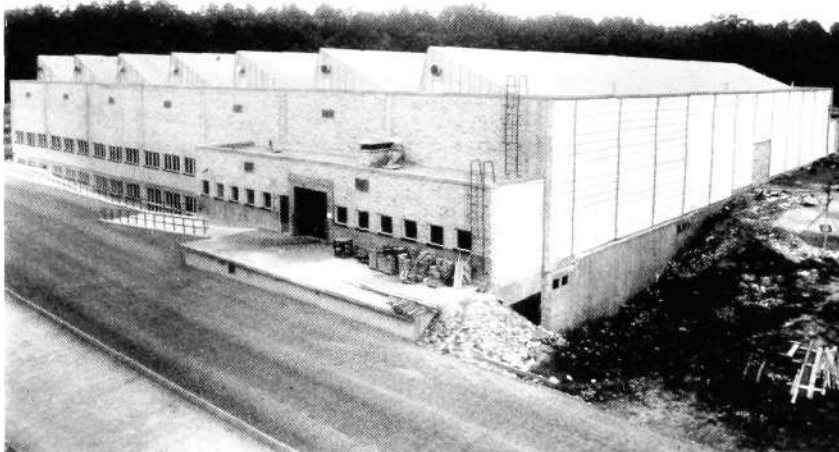
The first extension of the Älvsjö cable shop is 230 ft. in length and 200 ft. in depth. Work is shortly to start on the second stage, which will give the building a frontage of 500 ft.

(Below.) One of the new cabling machine assemblies.
